BST2023008

MAKE HYUNDAI

MODEL TUCSON (JM)

VERSION 2.0 (G4GC) 104 KW 141 HP 1975 Cm3

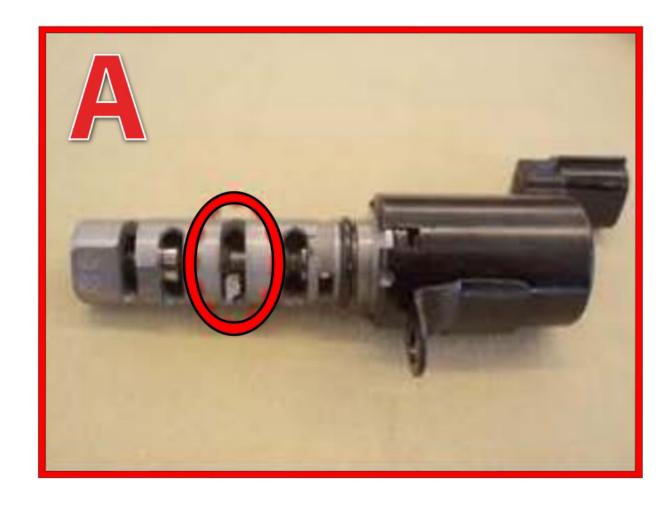
Defect in the variable timing valve.

A - Variable timing valve.

- Replace the variable timing valve if the values are not correct.
- Remove the variable timing valve if the values are correct.
- Check the variable valve for mechanical damage or metal chips. Clean it with compressed air or replace it if necessary. See picture 1.
